Manhole Inspection Summary

Manhole # S11AA1009MH

Insp Date: **7/11/07 10:52 AM**

Location Address: **3250 YOSEMITE RD**

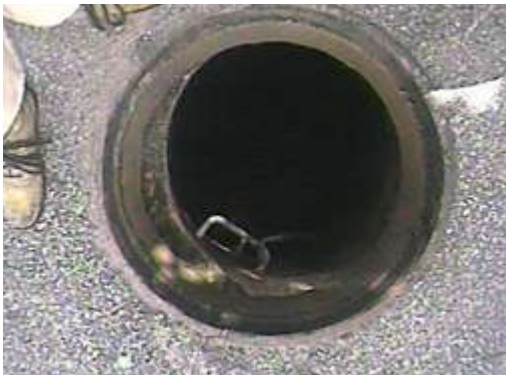
Top View

Offset: **2** (in.)

FRAME OFFSET

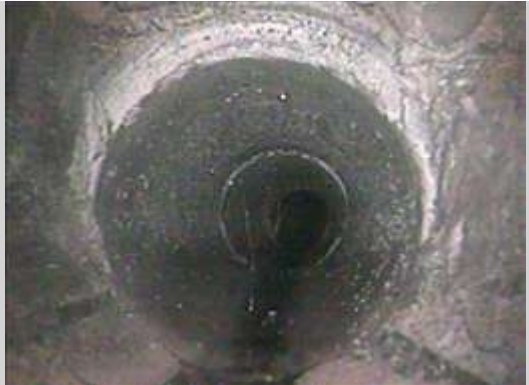
12 O'Clock Outflow

8 in. Circular Gravity Sewer
Pipe Out @ 12 O'Clock

Pipe Height: (in.) Direct
Pipe Material: **Clay** ☐ Pipe Lined
Invert Depth: **8.47** (ft.) Flow Characteristics: **Slow**
Deposits: ☒ None ☐ Mud ☐ Sludge ☐ Debris ☐ Grease
Silt Depth: (in.) Deposits Extent:
Infiltration: **None** Pipe Seal Cond: **Sound**

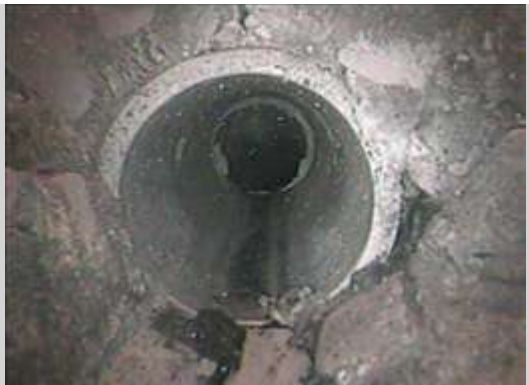
3 O'Clock Inflow

6 in. Circular Gravity Sewer
Pipe In @ 3 O'Clock

Pipe Height: (in.) Direct
Pipe Material: **Clay** ☐ Pipe Lined
Invert Depth: **8.03** (ft.) Flow Characteristics: **Slow**
Deposits: ☒ None ☐ Mud ☐ Sludge ☐ Debris ☐ Grease
Silt Depth: (in.) Deposits Extent:
Infiltration: **None** Pipe Seal Cond: **Sound**

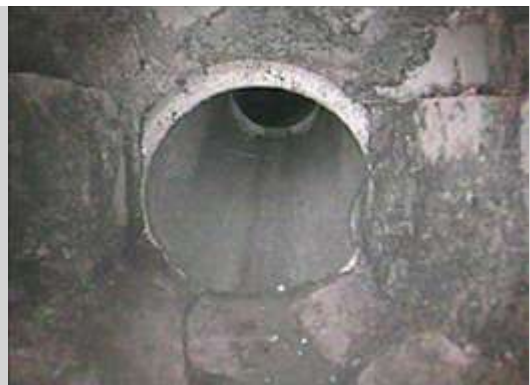
9 O'Clock Inflow

6 in. Circular Gravity Sewer
Pipe In @ 9 O'Clock

Infiltration: **None**

Pipe Seal Cond: **Sound**
